# Pre-Purchase Comprehensive Building Inspection Report

Comprehensive Property  
Inspections

1 Sample Place, Sample, 1234

Inspection prepared for: Sample Report  
Date of Inspection: 12/4/2015 Time: 12:30 PM  
Age of Home: Approx 12 Years Old  
Weather: Fine

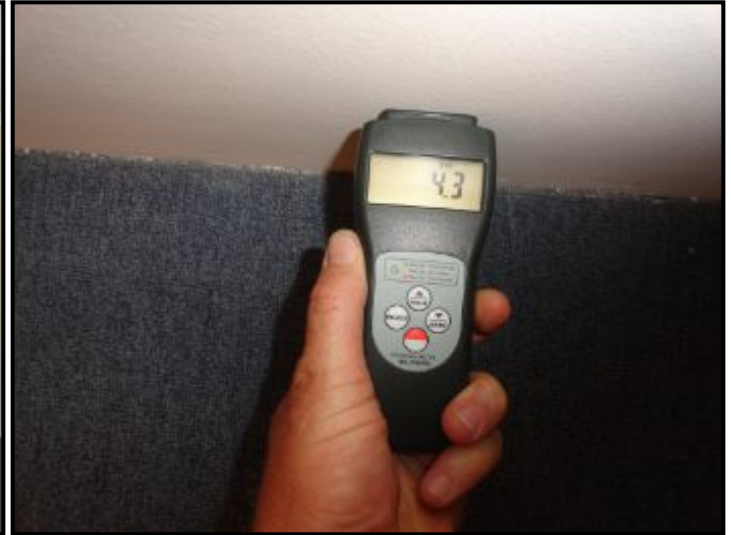
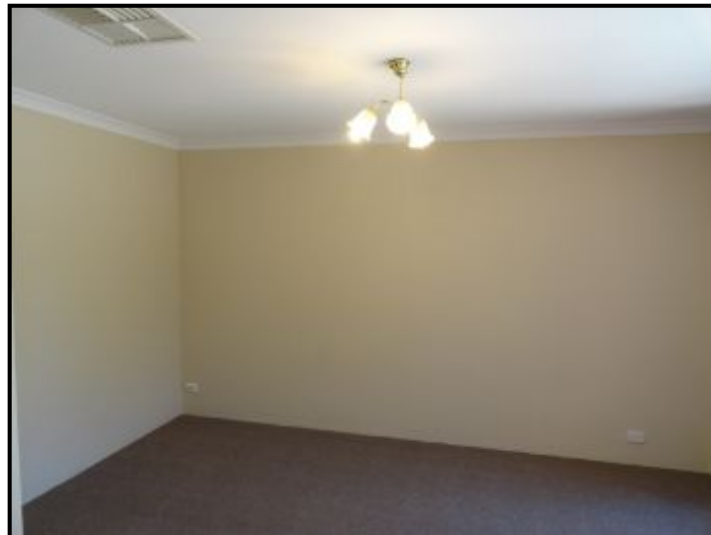
- The walls appeared functional and in average condition at the time of the inspection.
- The finish of the internal painting was in average condition generally. Some marks and stains were visible in some room areas. Any other associated marks, indents, holes, scratches, cracks and or poorly patched areas to some of the wall and ceilings internally which can be rectified prior to the next time of repainting.

Walls tested dry

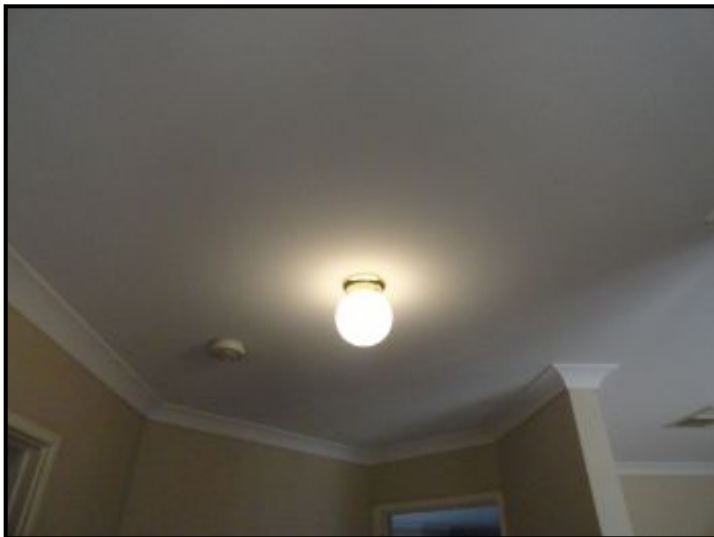
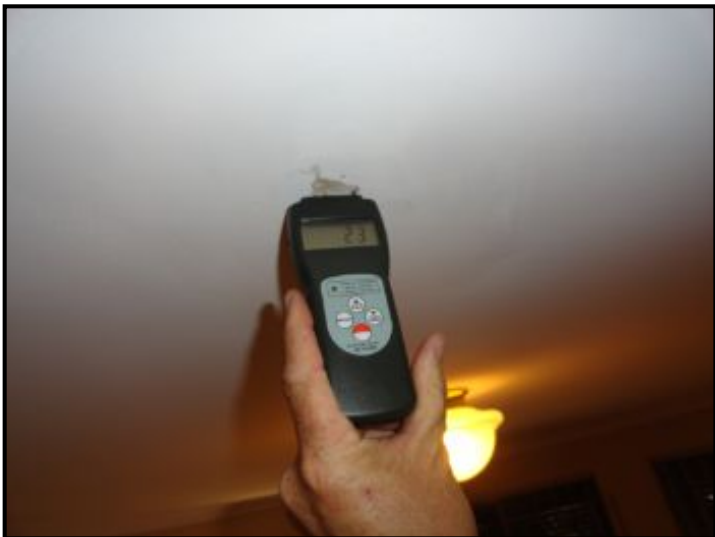
- The ceiling appeared functional and in average condition at the time of the inspection.
- Cornice joint cracking and cornice separation may be visible in some of the room areas. This is only minor and is normally common settlement only, unless otherwise stated in the body of this report.
- The plasterboard is patched in areas. The reason for the patch could not be determined.

Patched area tested dry

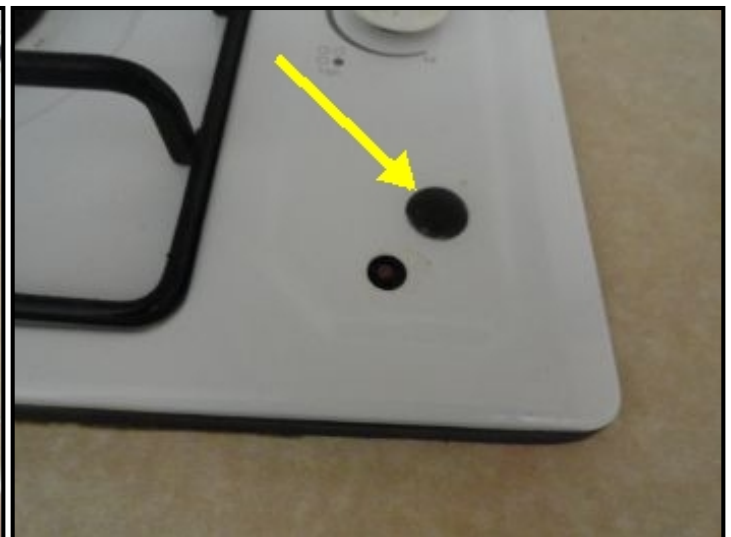
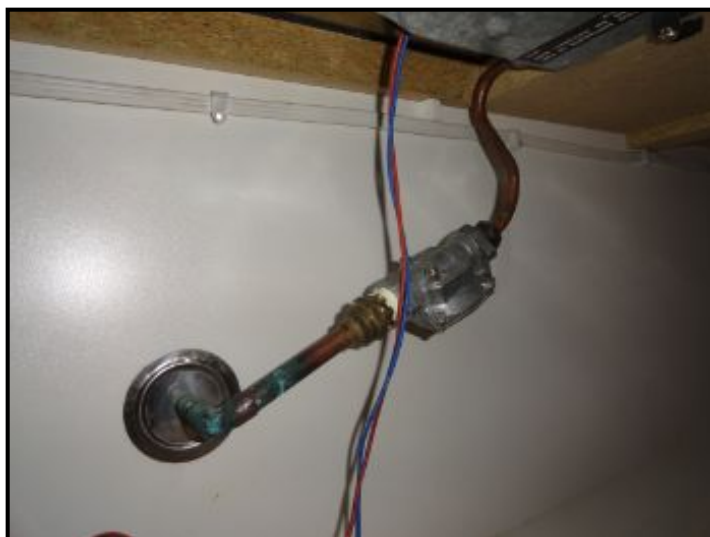
- Gas cook top noted.
- All burners operated when tested.
- Ignitor button loose. Review for repair.

Noted that ignitor button was loose

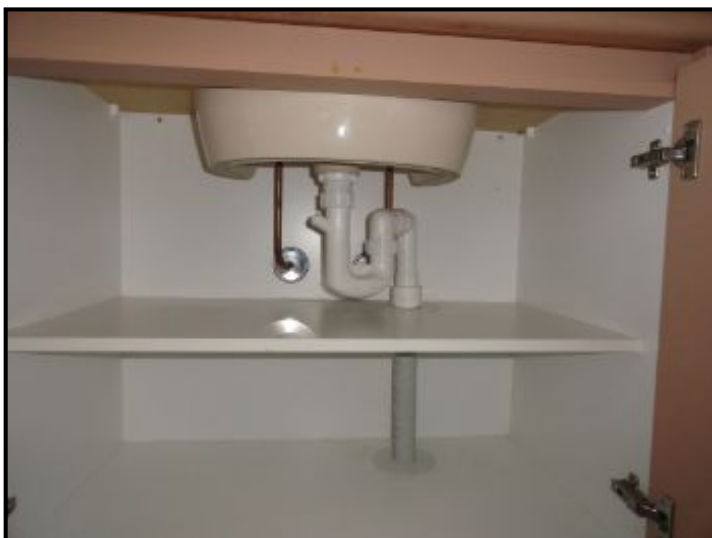
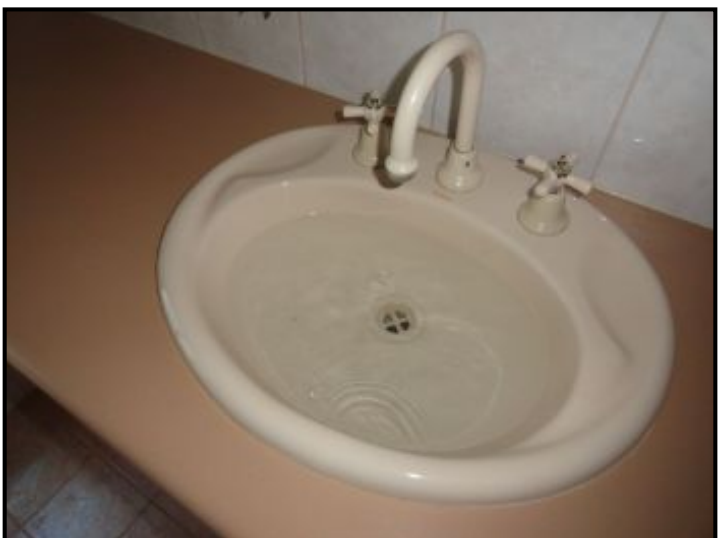
- Appears functional at the time of the inspection.
- The sink in the en suite bathroom drained slowly. This is usually caused by a blocked S Trap. Recommend using a drain cleaner to remove the blockage.

The sink in the en suite bathroom drained slowly.

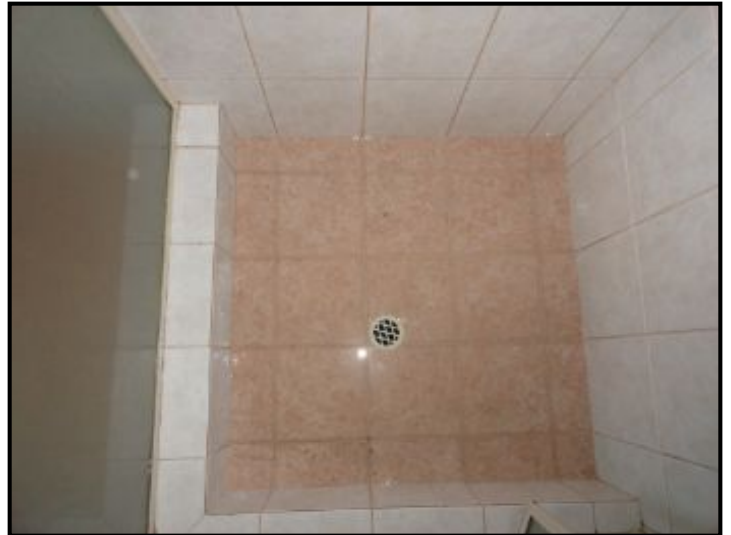
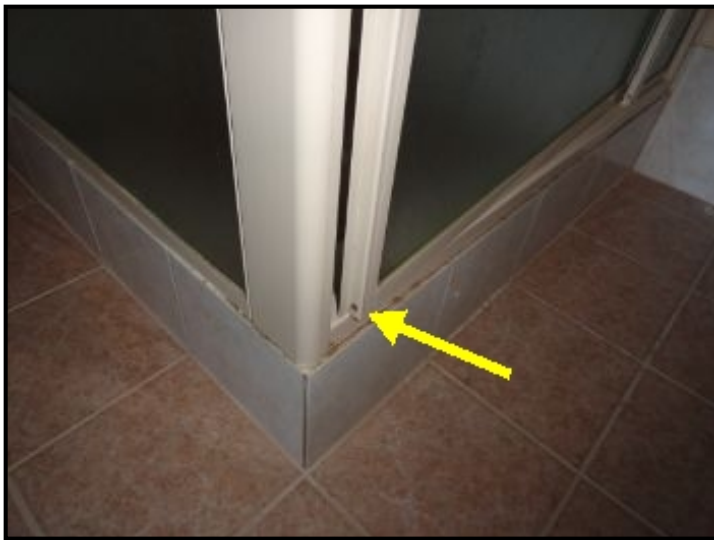
- **\*\*SHOWER BASE\*\***
- Tiled shower base noted.
- Appears functional at time of inspection.
- **\*\*SHOWER TAPS\*\***
- Hot and cold water taps noted.
- Appears functional at time of inspection.
- **\*\*SHOWER DOORS\*\***
- Glass shower screens noted.
- Curtain and curtain rail noted.
- Appears functional at time of inspection.
- Shower door catching on corner. Realign doors

Cracked tiles noted

Shower door catching on corner.

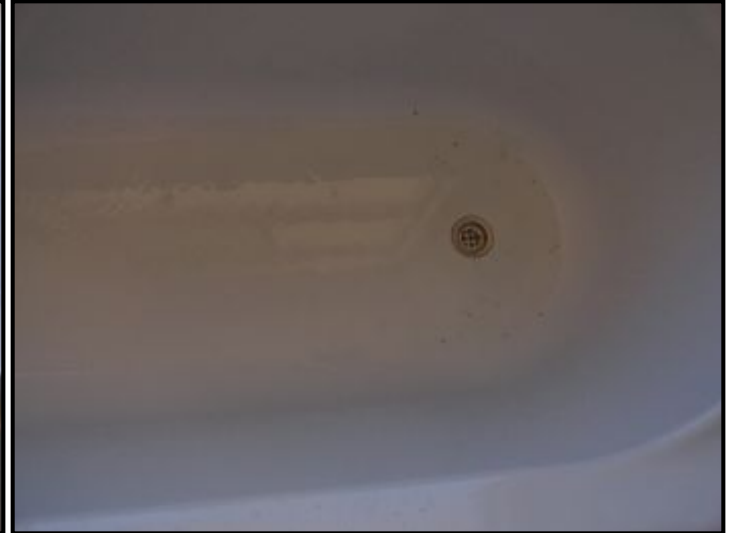
- Plastic bath tub noted.
- Appears functional at time of inspection.
- Noted that bath tub drained slowly. This is usually caused by a blocked Trap. Recommend using a drain cleaner to remove the blockage.

Noted that bath tub drained slowly.

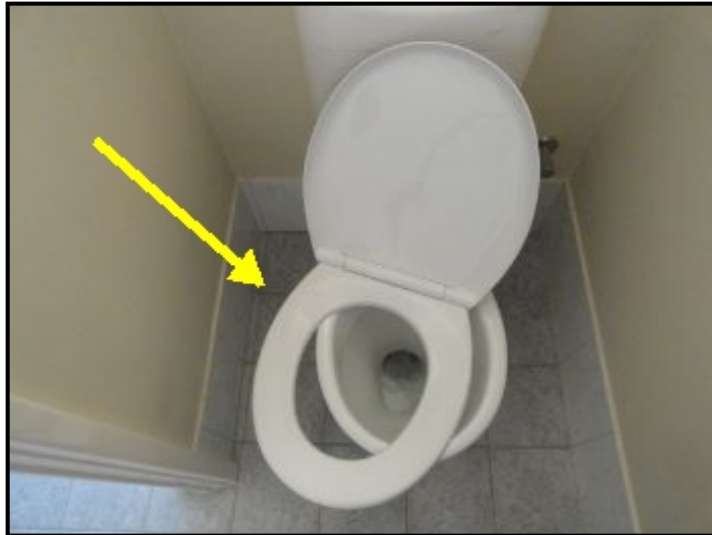
- Observed as functional when tested.
- Toilet seat cover loose; recommend tightening.

Loose toilet seat noted.

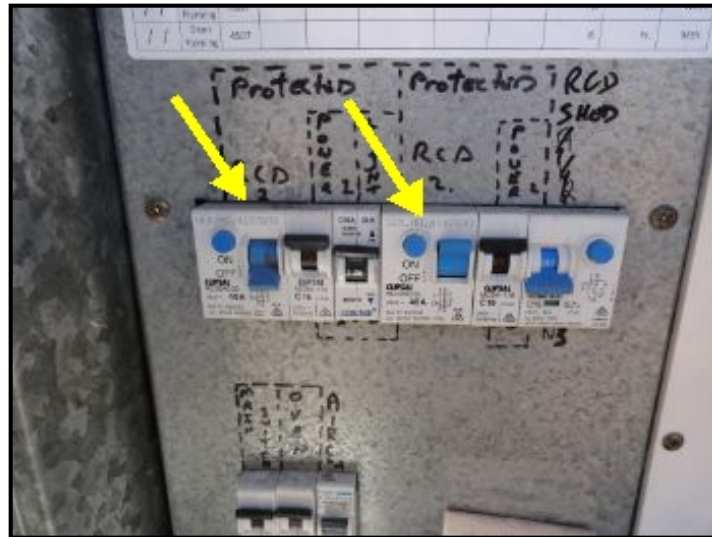
- Three safety switches were noted.
- **SAFTEY HAZARD: Two RCD switches are faulty and requires qualified electrician to review for repair or replacement.**

Faulty RCD noted

<b>Electrical</b>		
Page 24 Item: 1	Electrical Panel	• SAFETY HAZARD: Two RCD switches are faulty and requires qualified electrician to review for repair of replacement.
Page 25 Item: 2	Power Points	• SAFETY HAZARD: Safety switch did not trip when power points were tested. Recommend review by licensed electrician for repair or replacement, as necessary.
<b>Grounds</b>		
Page 39 Item: 1	Driveway and Path Condition	• SAFETY HAZARD: Uneven pavers noted to some areas. This is a tripping hazard, the pavers should be re-layed to have an even surface.

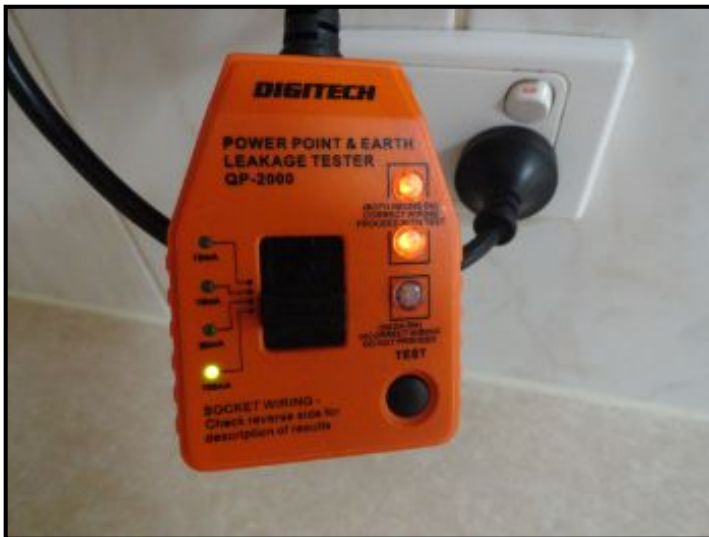
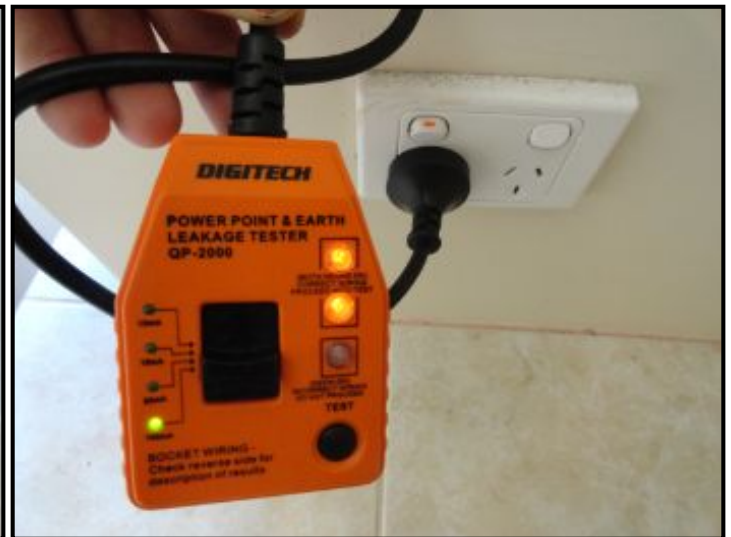
• **SAFETY HAZARD:** Safety switch did not trip when power points were tested. Recommend review by licensed electrician for repair or replacement, as necessary.

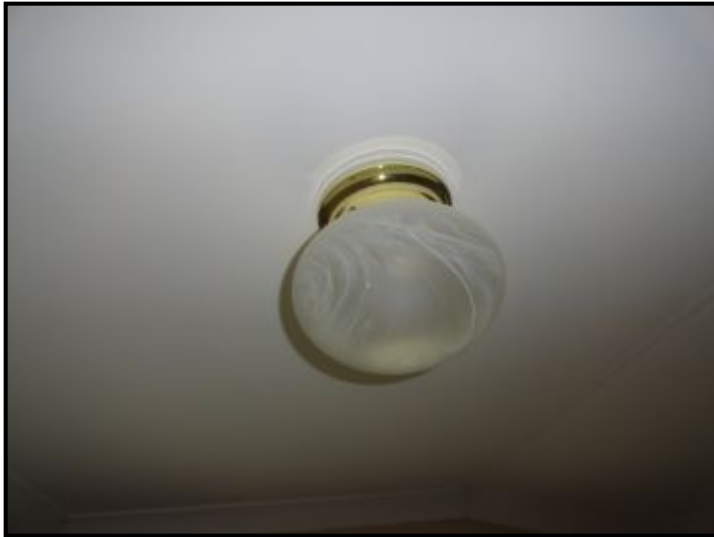
• Lights were not working at the time of the inspection as per the photos below.

Bathroom Light did not work

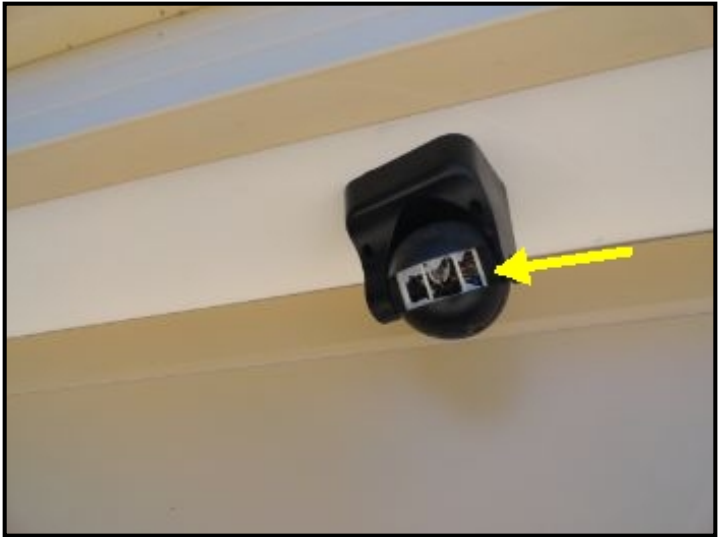
Damaged light sensor noted

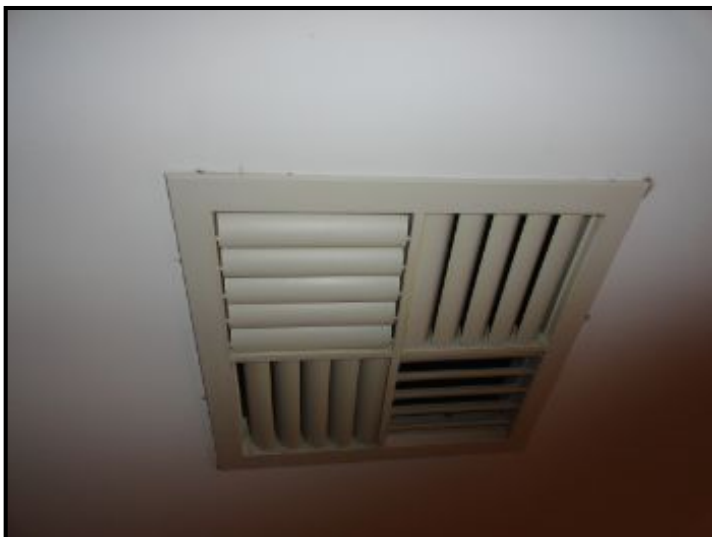
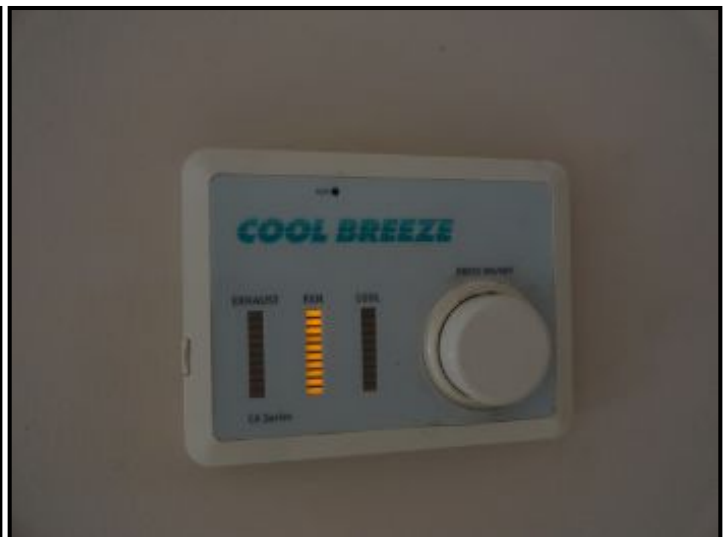
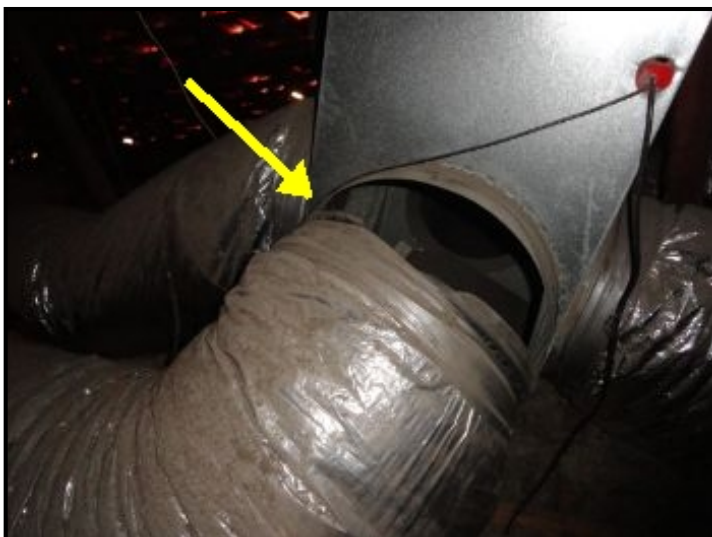
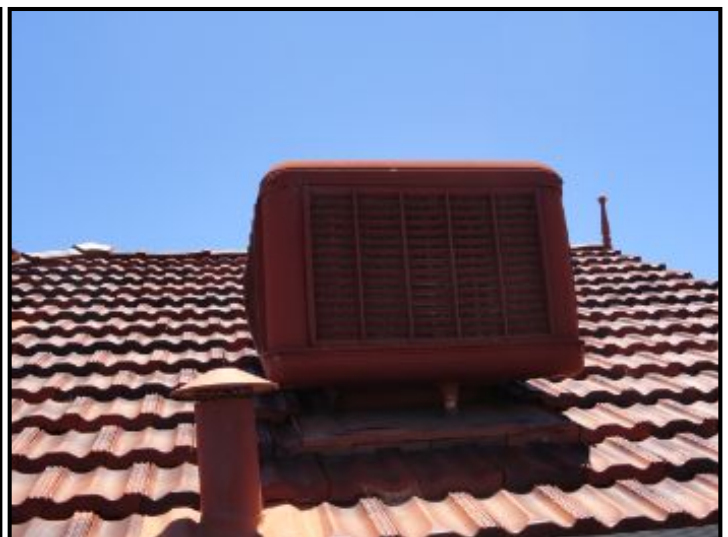
- The limit of testing for the air conditioner is turning the system on and checking that air is flowing into each of the rooms that has a vent. The ducting within the internal roof space is also checked for leaks.
- At the time of the inspection the air conditioner appeared to be functioning.
- Air conditioning systems should be regularly inspected every 12 months. Check with owner as to the service history and if necessary have the system serviced by an appropriately qualified service agent.
- Ducting has come loose from air conditioner splitter box. Reconnect ducting.

Ducting has come loose from air conditioner splitter box

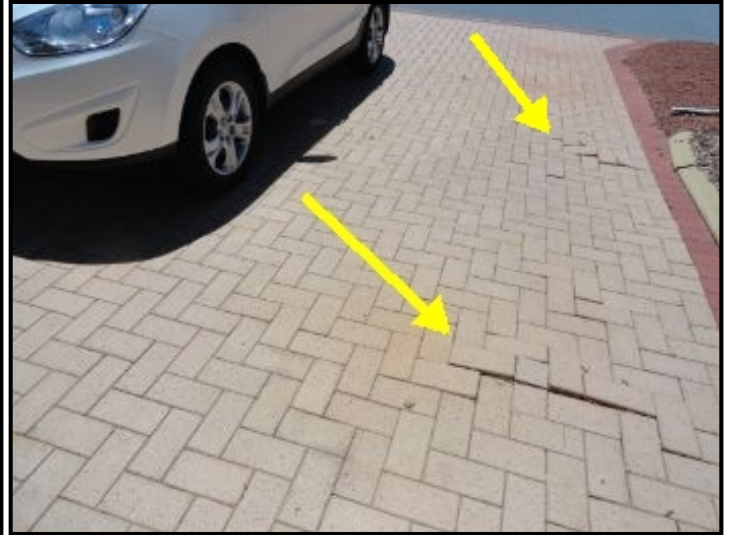
- Appeared functional and in average condition at time of inspection.
- **SAFETY HAZARD: Uneven pavers noted to some areas. This is a tripping hazard, the pavers should be re-layed to have an even surface.**

Uneven pavers noted to some areas.

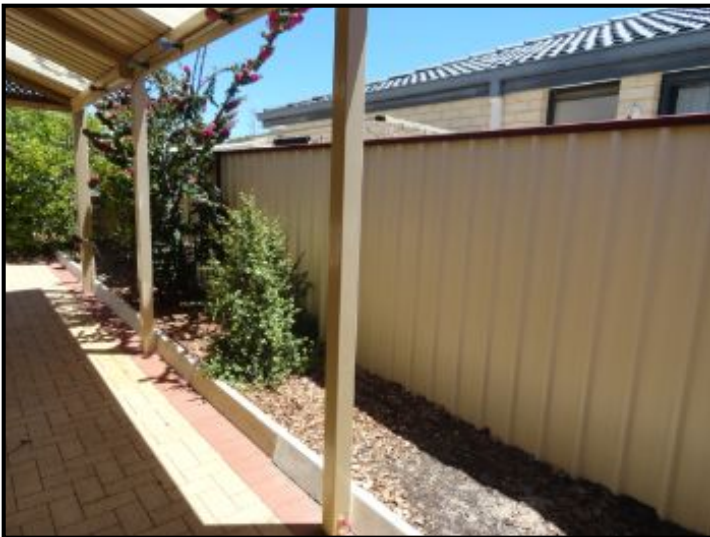
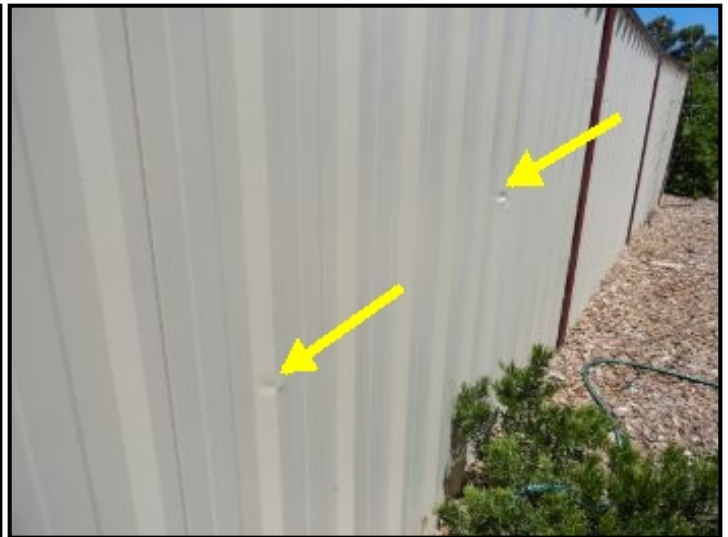
- Appeared functional and in average condition at the time of inspection.
- Noted that powder coated sheeting on fencing is dented in places.

Fencing is dented in areas

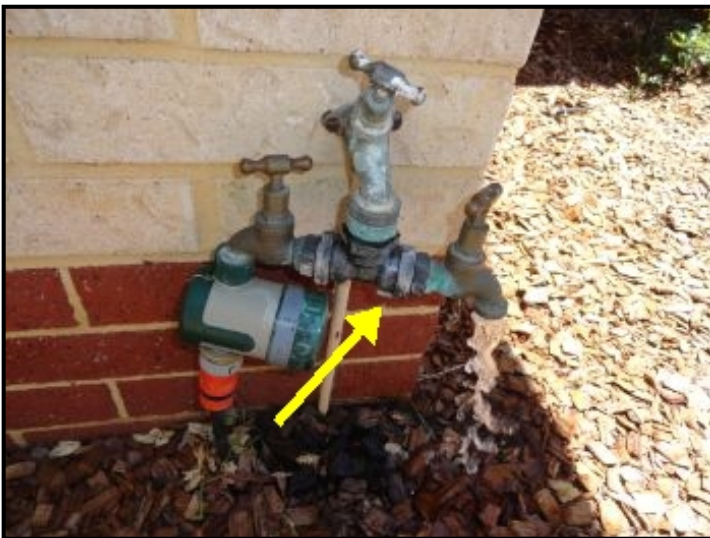
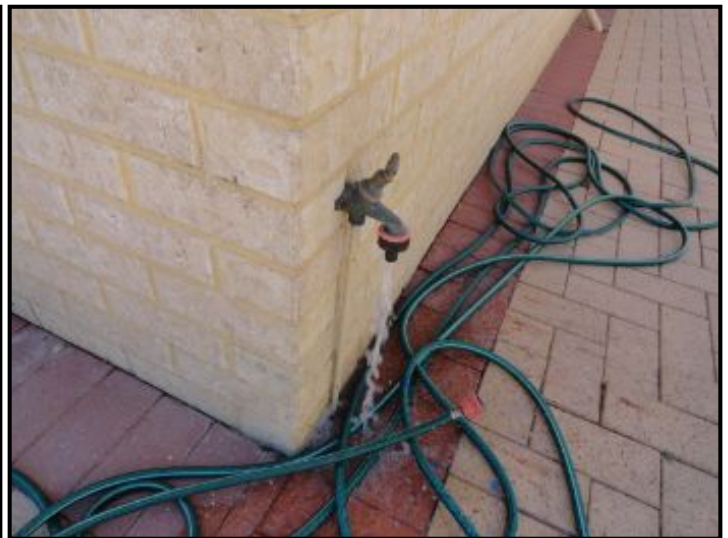
- Appears functional at time of inspection.
- The front tap is leaking. Review for repair.

Leaking tap noted

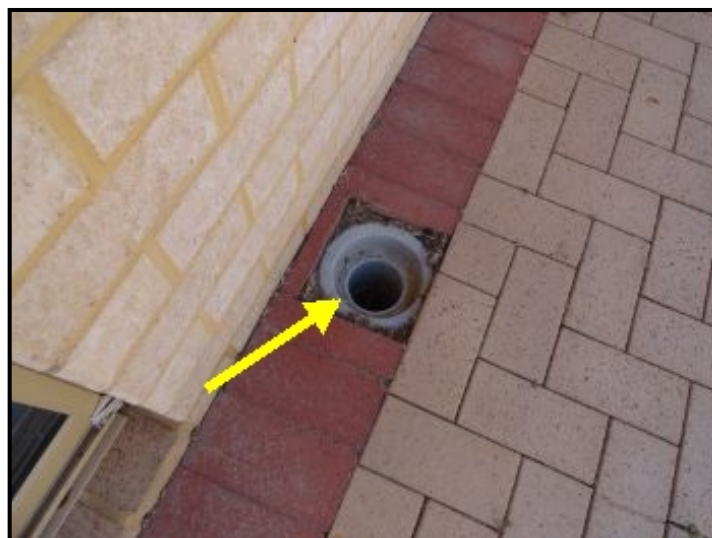
- Drain pipe missing a grate. Replace as necessary.

Drain pipe missing a grate.
